Delivery Operations

SUBJECT: Vehicle Fire Prevention

DAVCO Fuel Relocation Kit

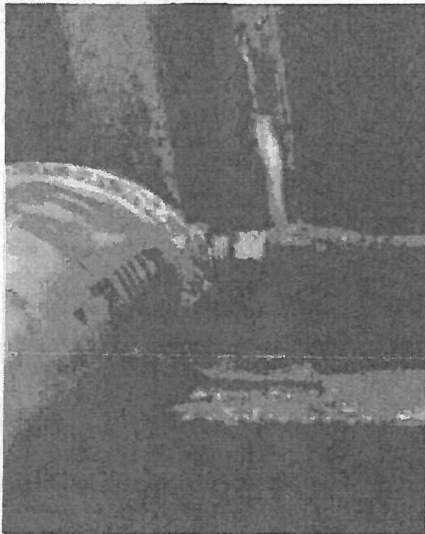
Figure 1 DAVCO Corroded Connector

The connectors coming from the tank and going to the Throttle Body Injection (TBI) must be completely free of corrosion, see Figures 1 & 2 above. Additionally the flexible fuel line that goes from the steel tubing after the filter around the transmission case and into the tubing that connects to the TBI must be trimmed and routed tight avoiding any exhaust components by at least 3 inches.

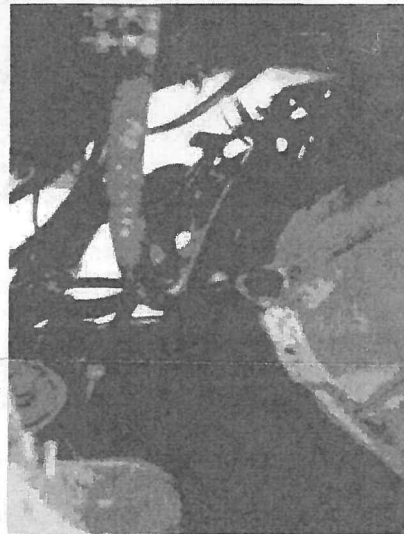
Figure 2 Improper Fuel Line Routing

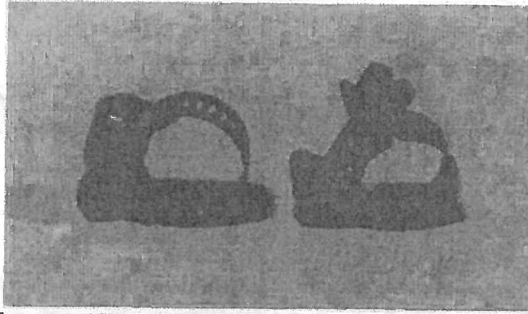
Figure 3 Worm Drive VS Barnes Fuel Line Clamp

The worm drive clamps supplied with the DAVCO kit have a specially sleeved liner that prevents pinch points. These clamps must be replaced if there is any corrosion or rust on them. The Barnes type fuel line clamp P/N 24154 & KP82709 (5/16" & 3/8" ID hose respectively) is a preferred replacement to the original worm drive clamps and should be used when replacing the worm drive clamp.

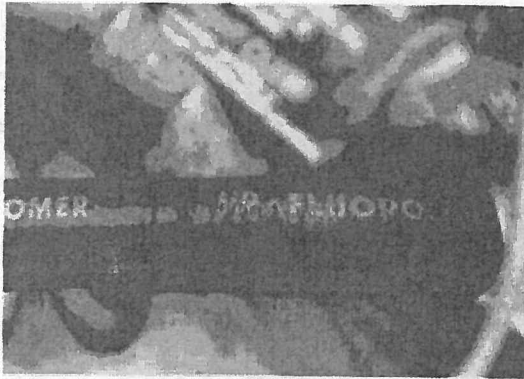
Flexible fuel line can be worn or heat stressed and in many cases damage will not be readily observable unless it is physically flexed; see figures 4 & 5 below.

Figure 4 Outside Fuel Line Cracking

When flexible fuel lines exhibit any deterioration they must be replaced with a suitable fuel line hose such as Dayco (P/N 80063, 80064 and 80065) or Goodyear SAE 30R7 type hoses.

Warning: Goodyear Instagrip and some Parker type hoses are air hoses and cannot perform the duties of a fuel line hose and will leak and cause a fire- assure that you are using fuel line hose rated at a minimum of 50 psi.

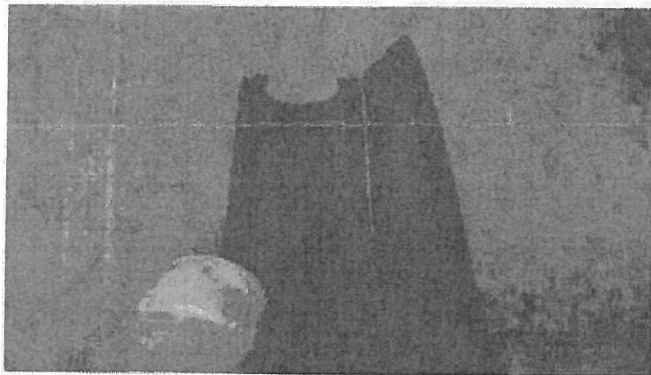
Figure 5 Inside Fuel Line Cracking

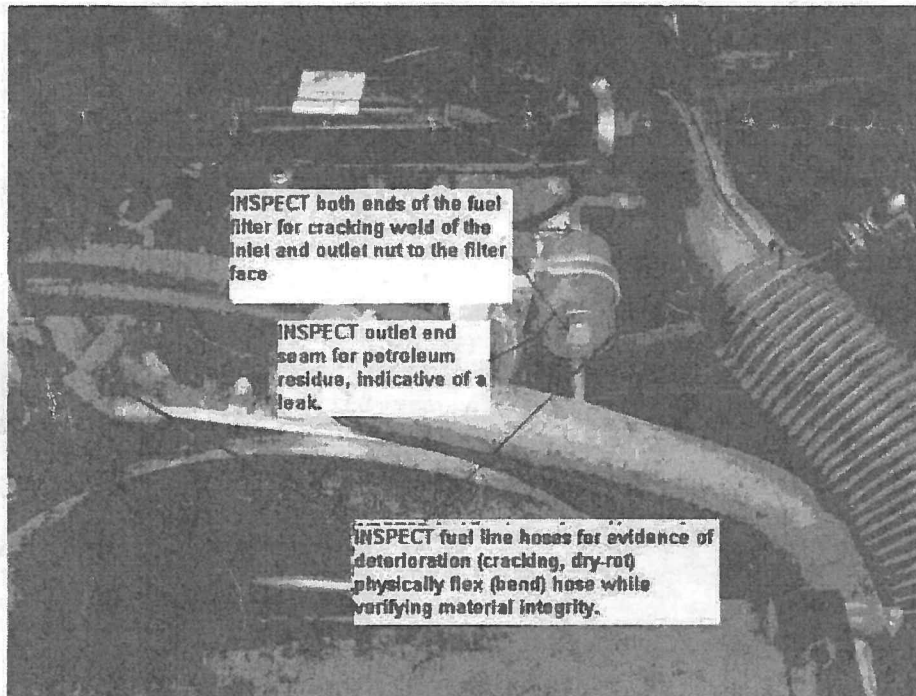
This kit is primarily comprised of Original Equipment Manufacturer (OEM) components along with some custom built parts. When discontinued parts require replacement, this system must be converted back to the original design.

Figure 6 Wheeler Bros Fuel Filter Relocation Kit

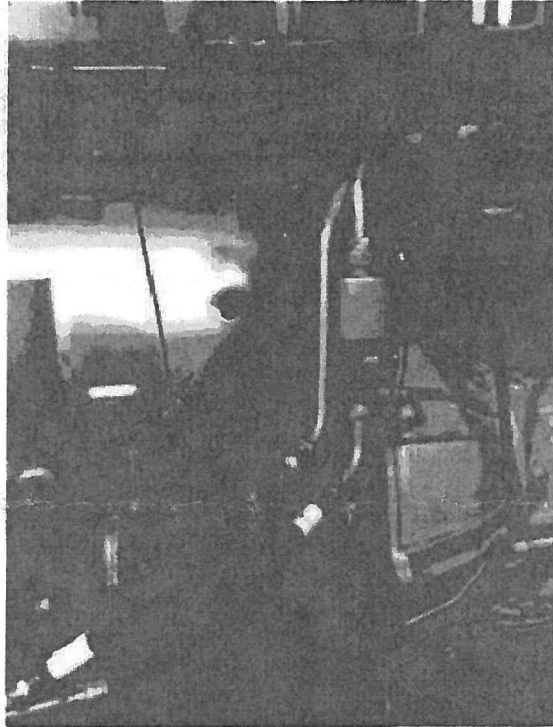
The GM original equipment configuration is similar to the DAVCO kit where flexible lines are routed close to exhaust components. Additionally, the canister type fuel filter is in a difficult spot to access and care must be taken to prevent cross threading or damage to O-rings. O-rings must be replaced during each filter change.

Figure 7 GM Original Equipment

The rubber return (USPS P/N 15590313) and supply (USPS P/N 15531858) hoses under the fuel filter are virtually hidden from view (see figure 7). The hoses must be physically flexed to gauge deterioration. The return hose configuration is common with all three fuel filter kits.
