An update on a fatal accident

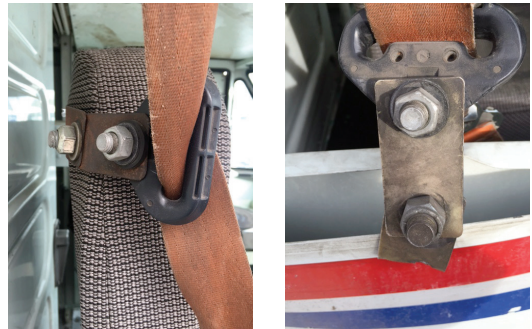
During its investigative process, the LVMPD was able to acquire the “airbag control module” of the vehicle that struck Hall’s LLV. The evidence established that the vehicle was traveling at 42 miles per hour at the time of impact. The force of impact may have broken the shoulder harness anchors as seen in the photos above that the NALC provided to the police department.

Photos provided to NALC following the crash that killed Las Vegas letter carrier Alton Hall.

...The anchor point was damaged on this vehicle and the ‘D-Ring’ was separated from the seatback. The seatbelt latch plate was seated in the buckle as I found it...

Please add a thorough inspection of your seatbelt harness to your inspection of your vehicle.
