Really?

Manuel L. Peralta Jr.

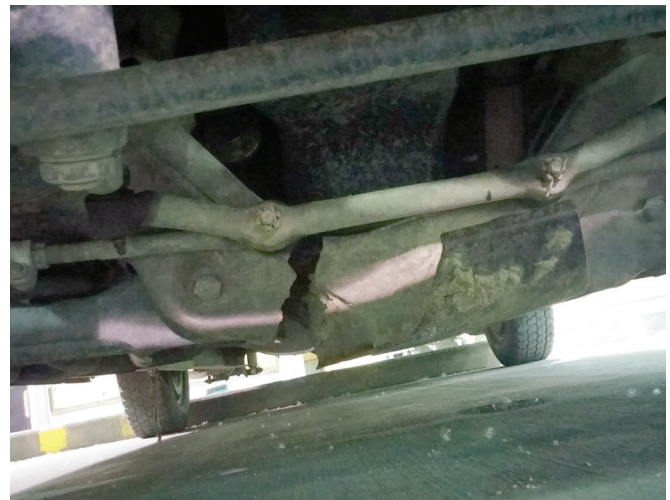
The photo you see at right shows a broken frame on an LLV used by a city letter carrier in the Western Area. The story could end there, but there are too many questions that come to mind to discount what happened before the photo and then what happened after the discovery.

The area where this vehicle is assigned frequently experiences snowfall and, as I write this article in late April, it was covered in snow today. I point this out because the magnitude of rusting to the frame is only experienced in snow country where the roads are salted. This, in turn, should result in extra attention being paid to the undercarriage of the vehicle during twice yearly preventative vehicle inspections, as per Section 341.3 of the PO-701. If your vehicle is used less than 500 miles per accounting period (AP), it is supposed to get "maintained" (serviced) on a 26-week cycle. If your vehicle is used more than 500 miles in an AP, it is supposed to be serviced on a 17-week cycle (three times per year).

Inspection items 34 and 36 take the mechanic's attention to the underside of the vehicle, where they should thoroughly inspect for fluid leaks and steering components. Item 39 takes them to the suspension, springs, shocks and the condition of the stabilizer bar. If all this is being done, one would have to cover their eyes to miss the magnitude of rusting that led to the collapse in the photo. It

An LLV with a broken frame used to deliver mail in the Western Area

is incomprehensible that a mechanic would miss the obvious rust buildup.

Obviously, this catastrophic failure of the frame to the vehicle in the picture was an unknown, but when it was discovered, what happened?

One of the vehicles in the same installation had previously required a frame replacement that took place about eight months earlier. We would expect that at the moment the frame failure was discovered, the vehicle would be immediately taken out of service before someone got hurt. I am advised that the reaction from postal management was to the effect of "They thought it would be all right for a while."

We have to make management live up to its responsibilities on safety. As the winter comes to a close, it would be a great time in snow country to insist on a proper inspection of the undercarriage to discover unsafe rusting before we get hurt.
