## ProMaster: To see or not to see

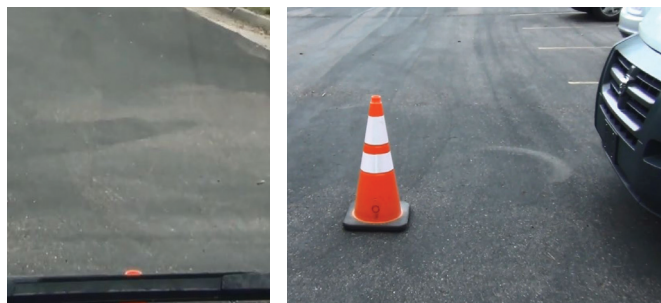
**We conducted a simple demonstration of the concern,** and the two photos on this page should help explain it. We placed an orange cone about four feet from the front bumper of the ProMaster. The cone stands 28 inches tall, which is a little taller than most toddlers. One of the drivers who participated in the testing, a 5-foot-7-inch woman, said that she was unable to see the top of the cone. The driver said that to see the cone, she had to lean forward over the steering wheel, half out of the seat. We believe that management simply should provide pot-lid mirrors to assist with viewing the blind spot, but management drew a line in the sand and said no.

**In the left photo, the orange cone—at 28 inches high, taller than most toddlers—is barely perceptible from the driver's seat. The photo at right shows the view of what could happen if letter carriers are not vigilant about what is in front of the vehicle. A simple solution would be pot-lid mirrors to help with visibility, but management has rejected the suggestion.**

tempting to convey. The first photo shows a barely perceptible portion of the very top of the cone; the second photo shows the view from the side showing what could happen if we are not vigilant about what is ahead of us. Don't assume that no one has stepped in front of your path.
